# **Patterns of Injuries to Front-Seat Occupants of Airbag Equipped Vehicles in Frontal Crashes**

CIREN Public Meeting  
University of Washington  
Harborview Medical Center  
August 22, 2002

Lawrence W. Schneider, Ph.D.  
Stewart Wang, M.D.  
Jonathan Rupp  
Joel B. MacWilliams

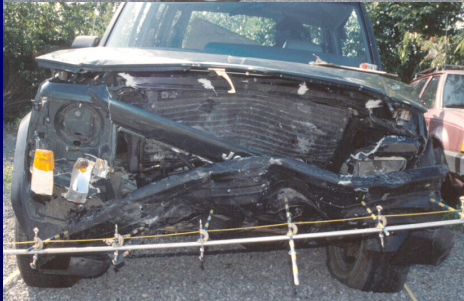
**28-mph  $\Delta V$**   
CDC = 12-FDEW-3

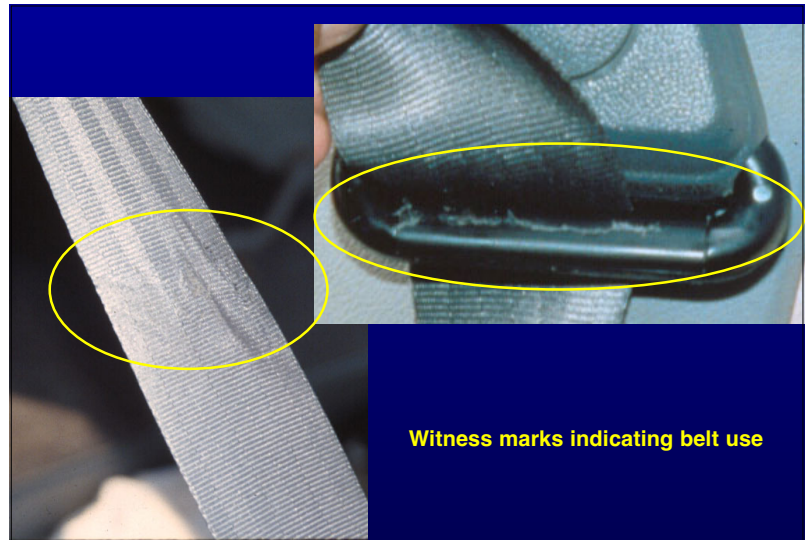
**Witness marks indicating belt use**

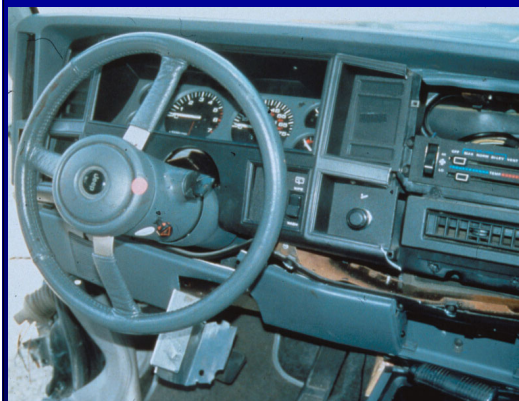
Severe steering-wheel rim deformation

- 45 year-old male driver; 6' 0"; 205 lb
- 3-point belt worn, no airbag available
- AIS-2 facial fractures from head contact with SW
- AIS-2 lower extremity fracture present

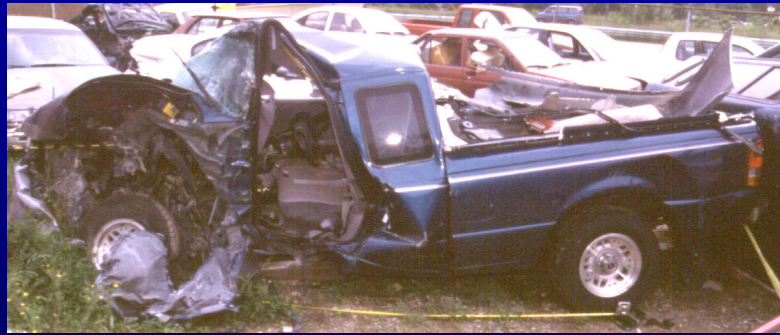
**25-mph +  $\Delta V$**   
CDC = 12-FYEW-3

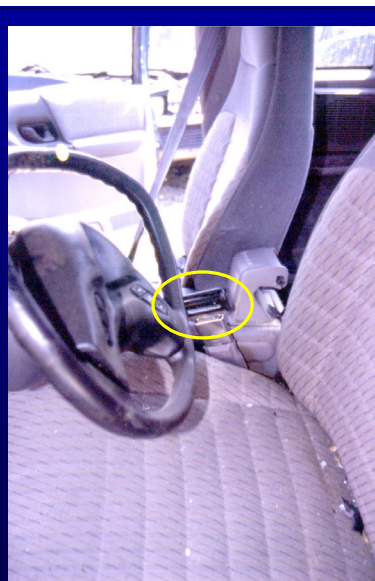
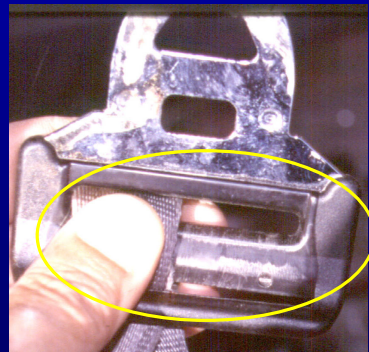
**Latch found in receiver**  
**Load marks on continuous loop**

- 53 year-old female driver; 5' 10"; 180 lb
- 3-point belt worn, no airbag available
- AIS-4 head/brain injuries from steering-wheel contact
- AIS-4 chest and AIS-3 abdomen injuries from belt loading
- AIS-3 pelvic and AIS-2 lower extremity fractures□□ also occur

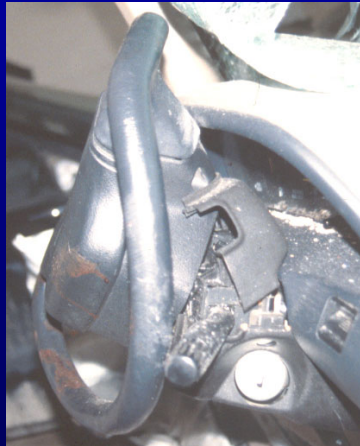
Severe SW rim deformation

- 20 year-old male driver; 6' 0"; 182 lb
- 2-point automatic shoulder belt worn, no airbag available
- AIS-2 abdominal (visceral) injury from belt loading
- AIS-3 lower extremity fracture from knee contact with knee bolster (axial load )

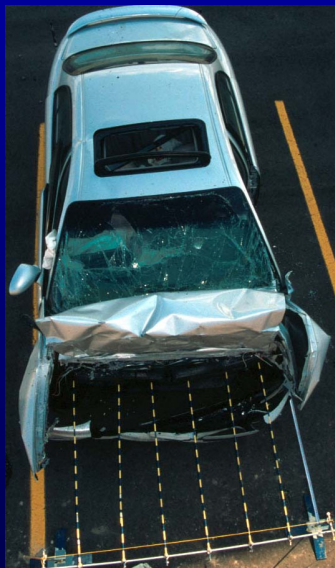
CDC: 12-FDEW-5  
 PDOF: 360 degrees  
 160 cm of direct damage  
 108 cm of maximum crush

**Impact Severity (mph):**

total	60
longitudinal	- 60
lateral	- 0

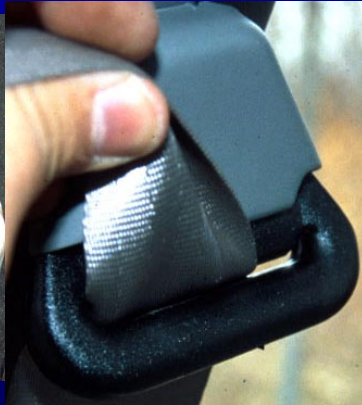
**No evidence of belt use**

- 40 year-old male driver; 6' 0"; 210 lb
- 3-point belt not worn, frontal-impact airbag deployed
- AIS-3 facial fractures from head contact with upper instrument panel
- AIS-3 chest injury from crash forces
- no brain, neck or abdominal injuries
- disabling lower-extremity fractures

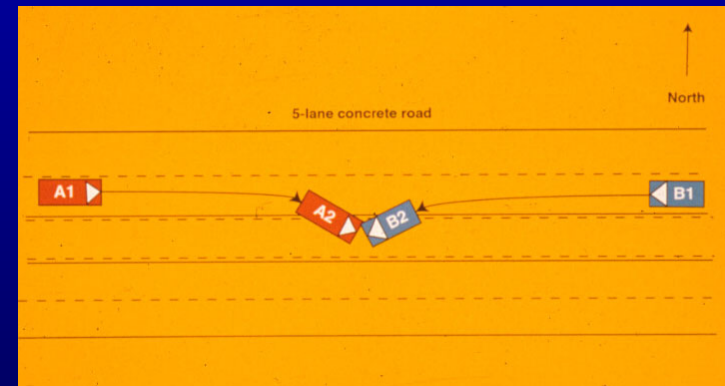
Case Vehicle (A): 1996 Ford Crown Victoria (in red)

Vehicle (B): 1990 Toyota Celica

V2 traveling in wrong lane, both drivers swerve to miss each other and hit headon

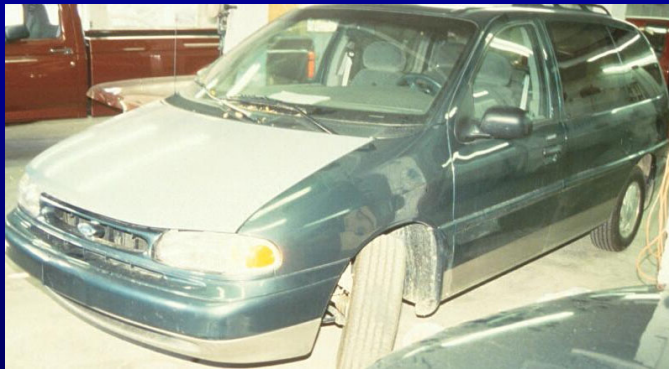
**1-2 mph  $\Delta V$**

CDC = 12-FDEW-1

Displaced, comminuted right distal radius fracture and  
right ulnar styloid process fracture from loading by inflating airbag

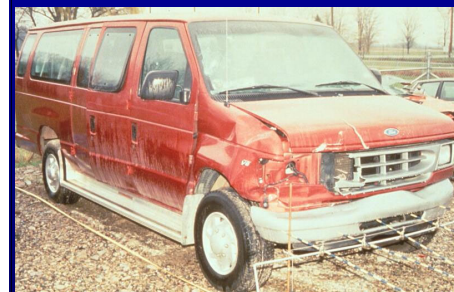
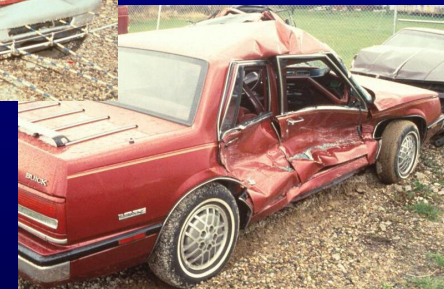
11-mph  $\Delta V$

CDC = 12-FDEW-2

22-mph  $\Delta V$

CDC = 02-RPAW-3

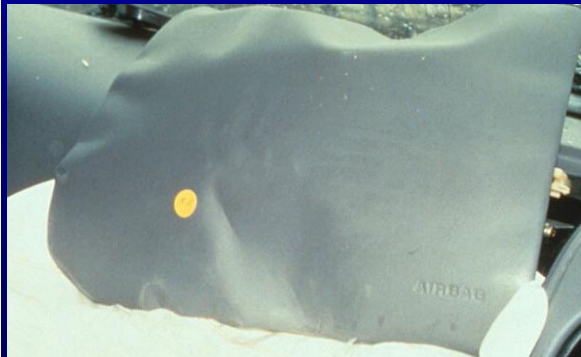
Hand print visible on AB module cover  
Severely comminuted radius and ulna fractures

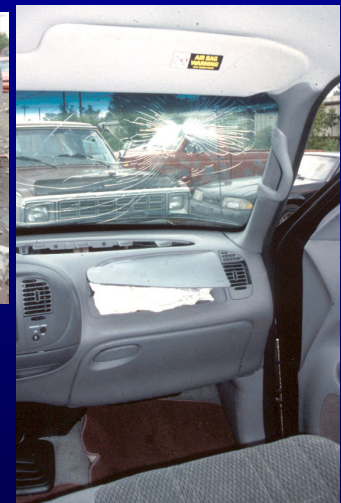
- 1997 Ford F-150 pickup
- Low speed, pre-impact braking
- Unbelted 9-year old RF passenger
- AIS-5 brain injury from airbag inflation and/or airbag fling into WS and WS header

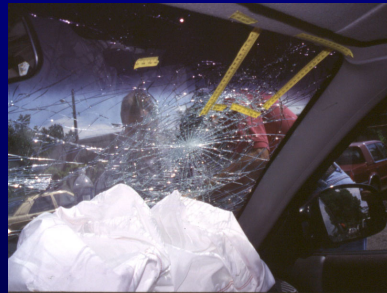
- 1998 Pontiac Grand Prix
- pre-impact braking, 18 mph  $\Delta V$
- unbelted 7 year-old RF passenger
- AIS-2 facial fracture from contact with AB cover
- AIS-3 skull fracture from contact with WS and WS header (airbag fling)
- AIS-4 brain injuries from contact with WS and WS header (airbag fling)

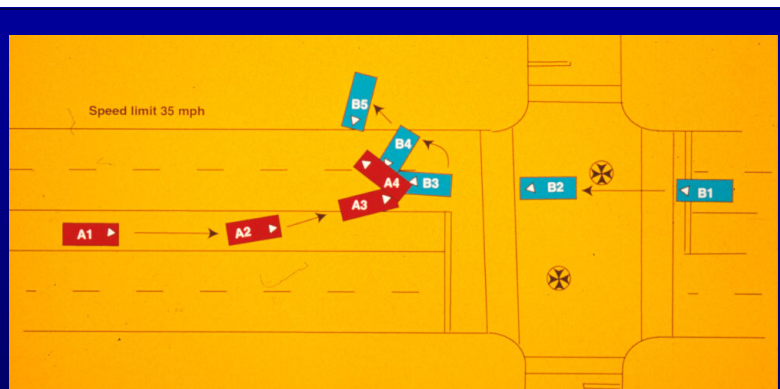
Case Vehicle (A): 1997 Ford Escort, 4-door station wagon (in red)  
 Vehicle (B): 1998 Pontiac Grand Am  
 Vehicle (A) attempted wide left turn and struck vehicle (B) headon  
 Daylight, clear, dry asphalt roadway

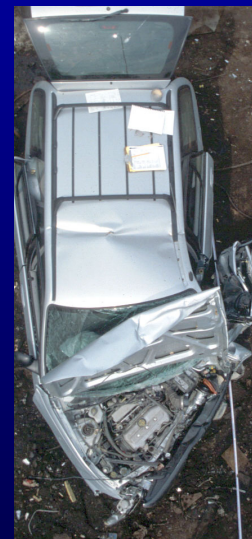
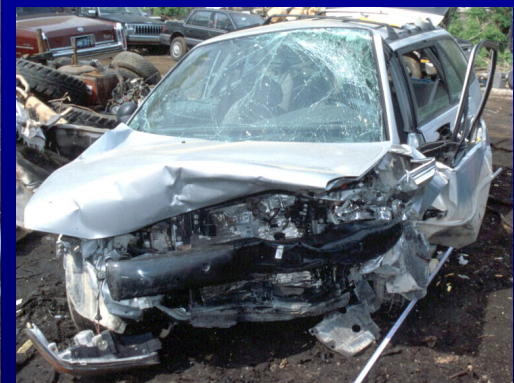
**46-mph  $\Delta V$**

CDC = 12-FYEW-5

- 61 year-old female driver; 5' 6"; 170 lb
- 3-point belt worn, steering-wheel airbag deployed
- AIS-3 chest and pelvic injuries from belt loading
- No head, brain, neck or abdominal injuries
- AIS-2 lower extremity fractures still present

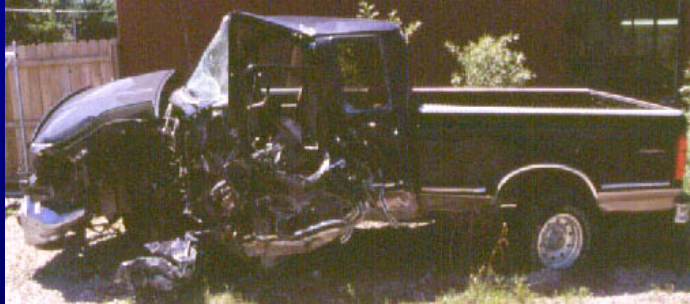
Left wheel base reduced 57 cm

- 37 year-old male driver; 5' 10"; 230 lb
- 3-point belt worn, airbag deployed
- AIS-2 brain injury from crash forces
- No chest, abdomen, or pelvic injuries
- AIS-3 lower extremity fractures still present

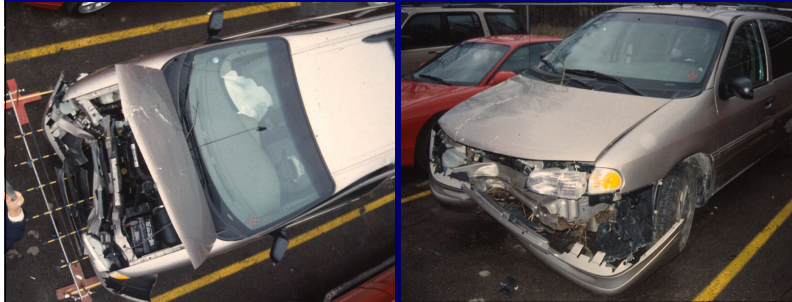
Case Vehicle - 1997 Ford Windstar

CDC: 12-FZEN-3

24-mph delta V

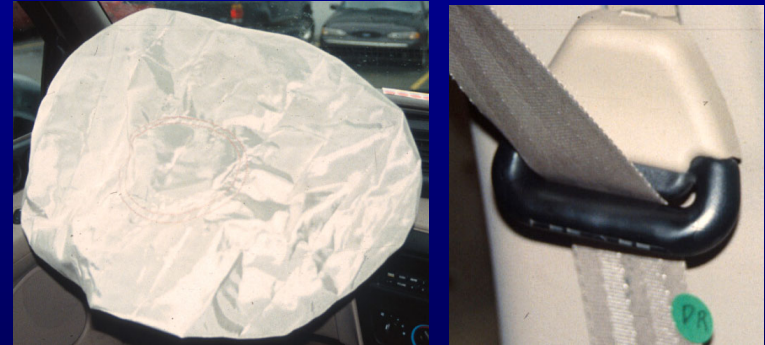
Driver was wearing the belt restraint and the airbag deployed

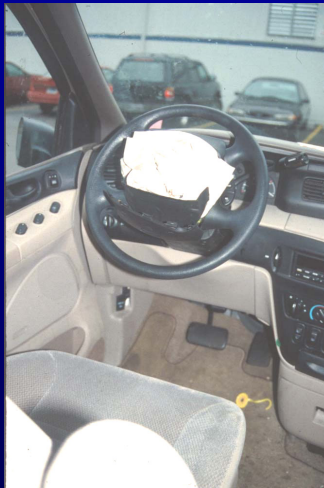
No intrusions in the driver area

- 17 year-old male; 5' 9" 166 lb
- 3-point belt worn
- frontal-impact airbag deployed
- no intrusions
- pre-impact braking
- AIS-3 pelvic injury from axial loading through foot contact with brake pedal
